**APPLICATION FOR SITE CERTIFICATION TO THE
GEORGIA ALLIES GRAD INDUSTRIAL SITE PROGRAM**

Worth County Economic Development Authority
122 North Main Street
Sylvester, Georgia 31791
P: 229-776-7599
F: 229-776-0233

EMC Engineering Services, Inc.
1344 US Hwy 19 S Suite A
Leesburg, Georgia

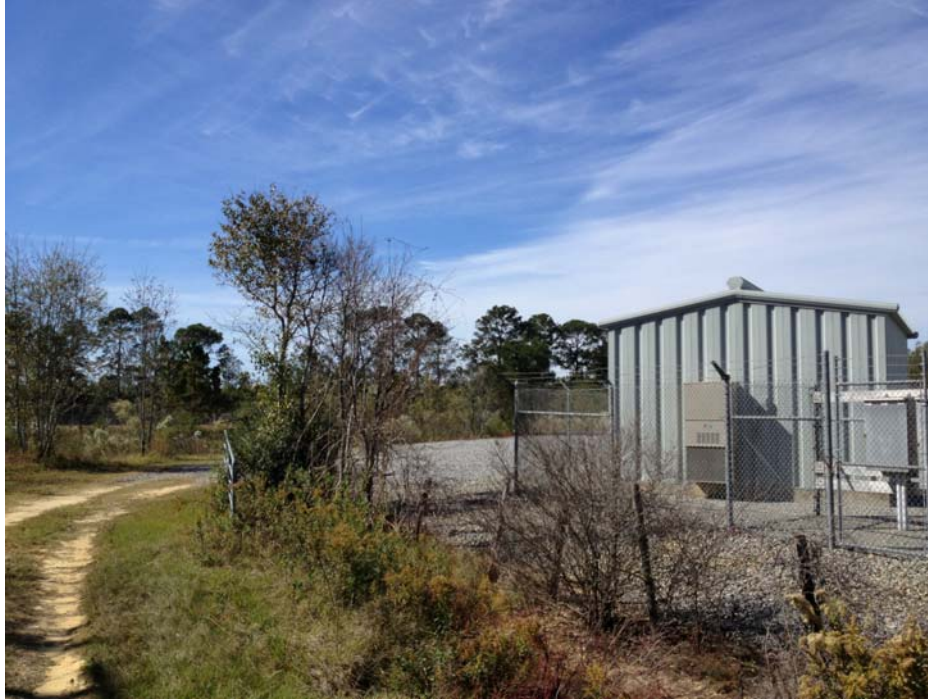
Figure 9: Farmers access on southwest corner of property.

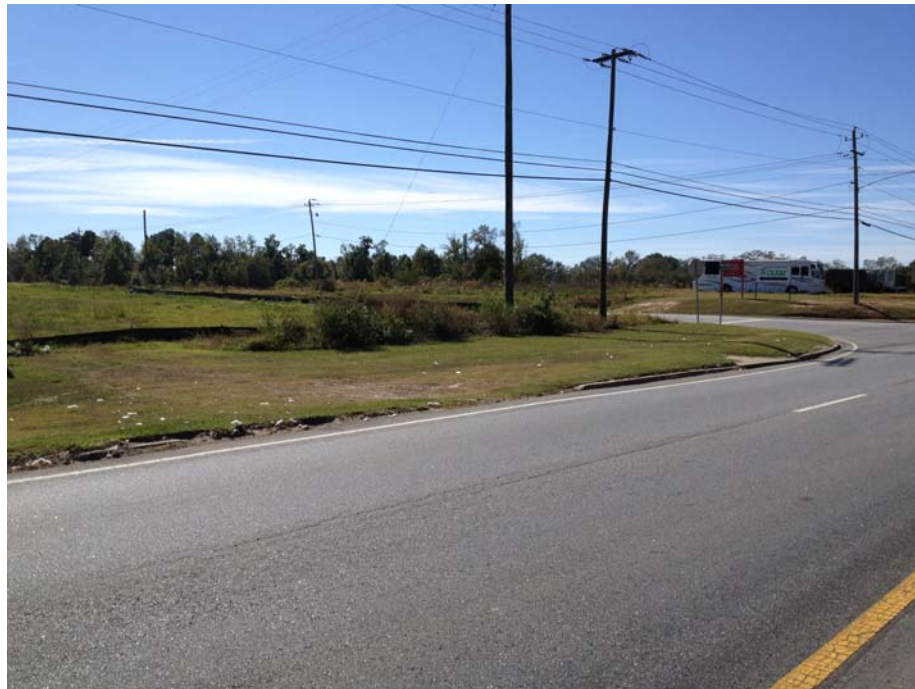
Figure 10: Driveway located on northwest corner of property connected to Hwy 82.

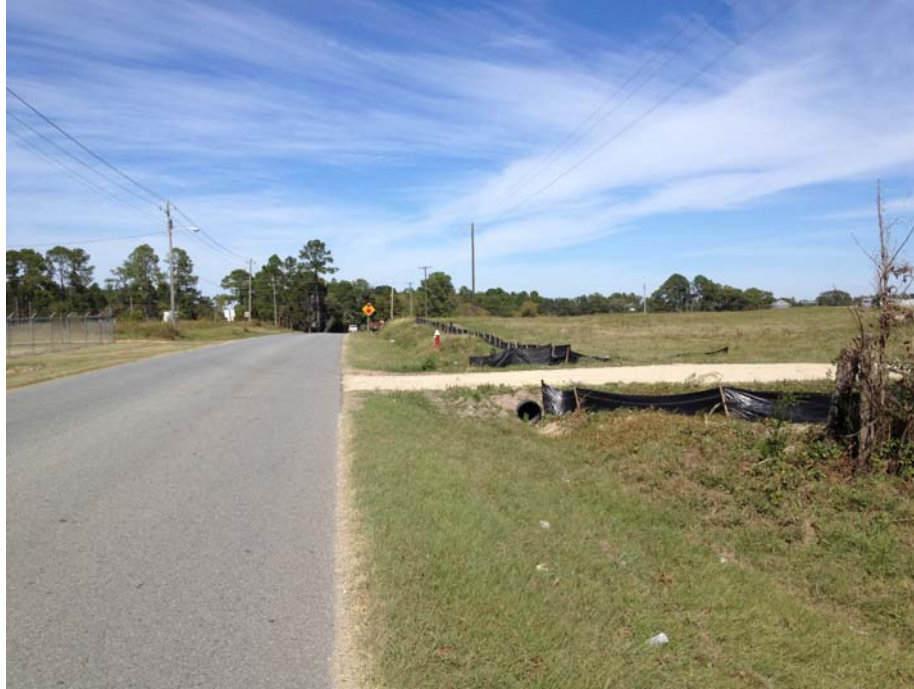
Figure 11: New access added approximately 600 feet south front the intersection Hwy 82 and Seabrook Drive.

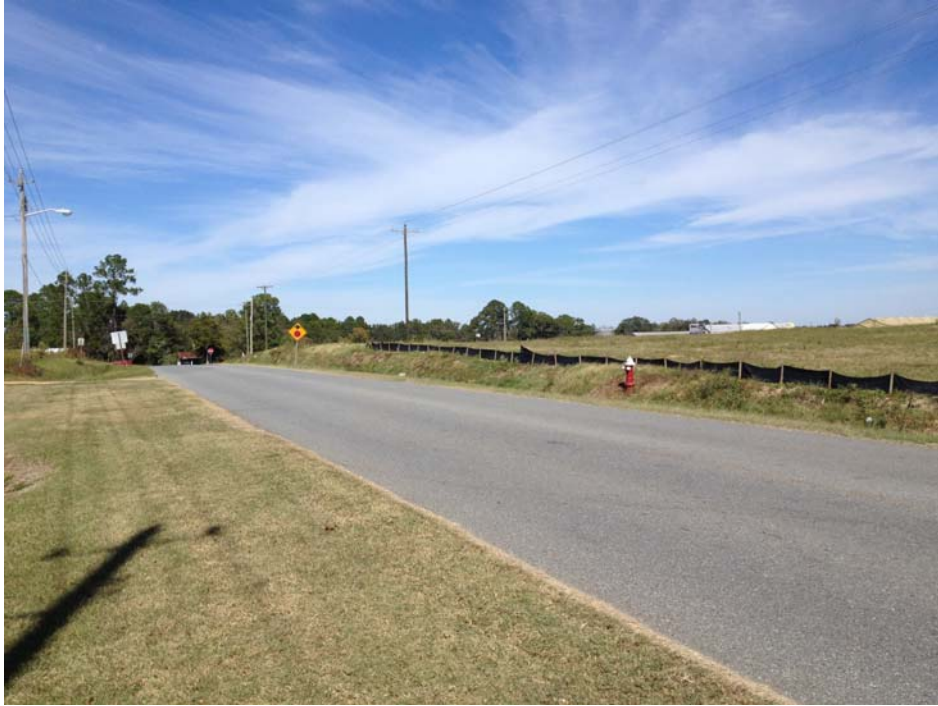
Figure 16: Water line on Seabrook Drive running down the west side of the property

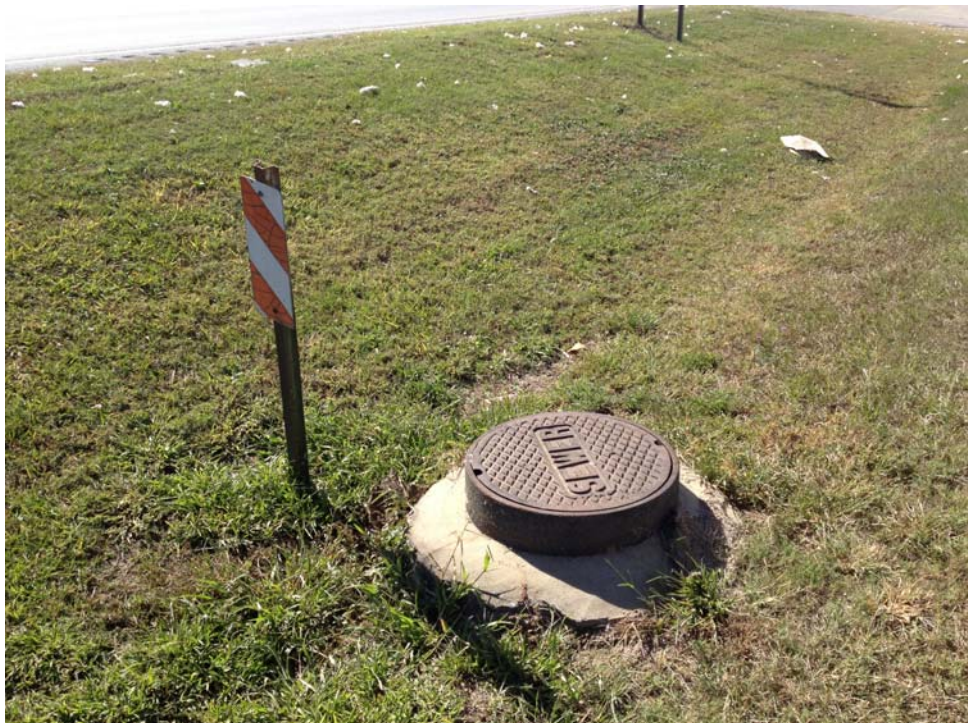
Figure 17: Sewer line running across the street along Hwy 82 on the front of the property.

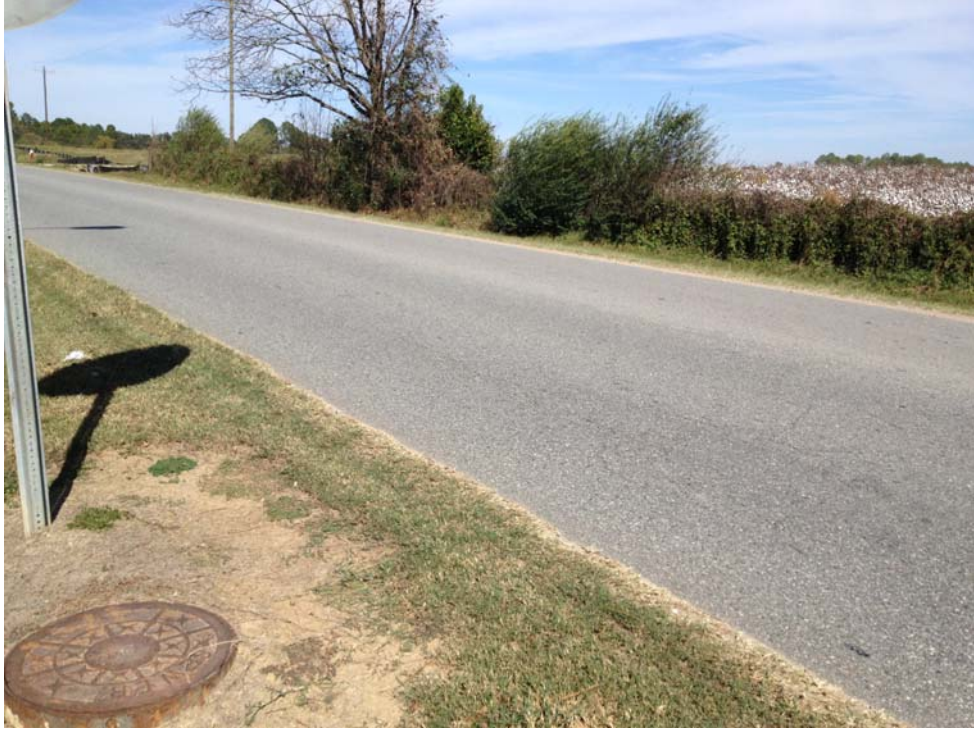
Figure 18: Sewer line located on Seabrook Drive with proposed site across the street.

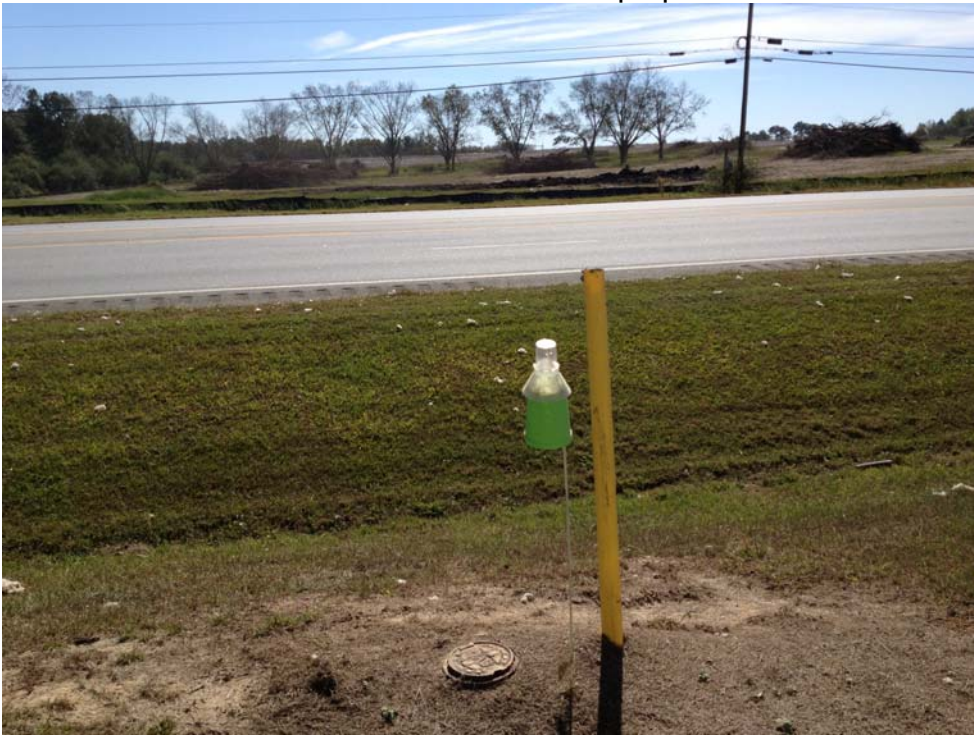
Figure 19: Gas line across Hwy 82 running across the north side of the property on opposite site of the road.

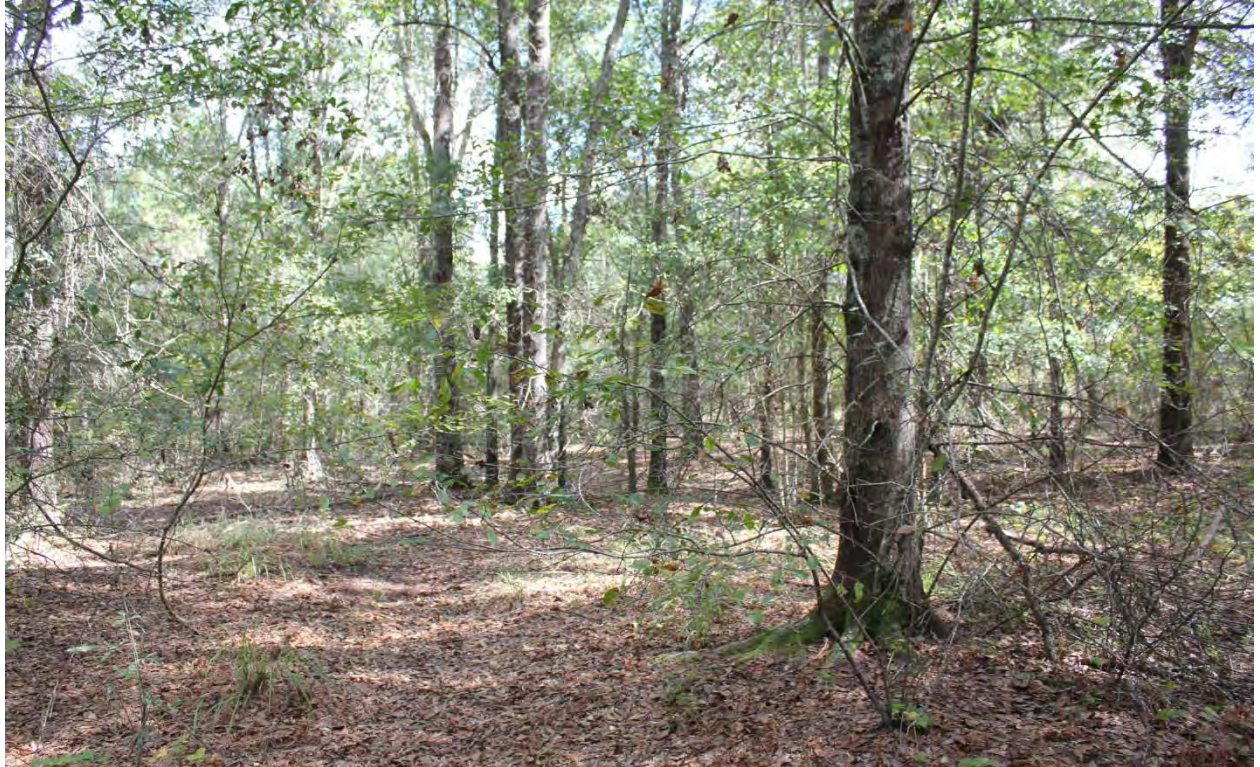
Photograph 12. Mixed hardwood/pine upland

3.6 Mixed Hardwood/Pine Upland: (Photograph 12 & 13, Figure 2) Upland mixed hardwood/pine is generally located along the transition zone between the wetland systems and the open agriculture field. These areas contain a mature overstory and species composition and distribution is as follows:

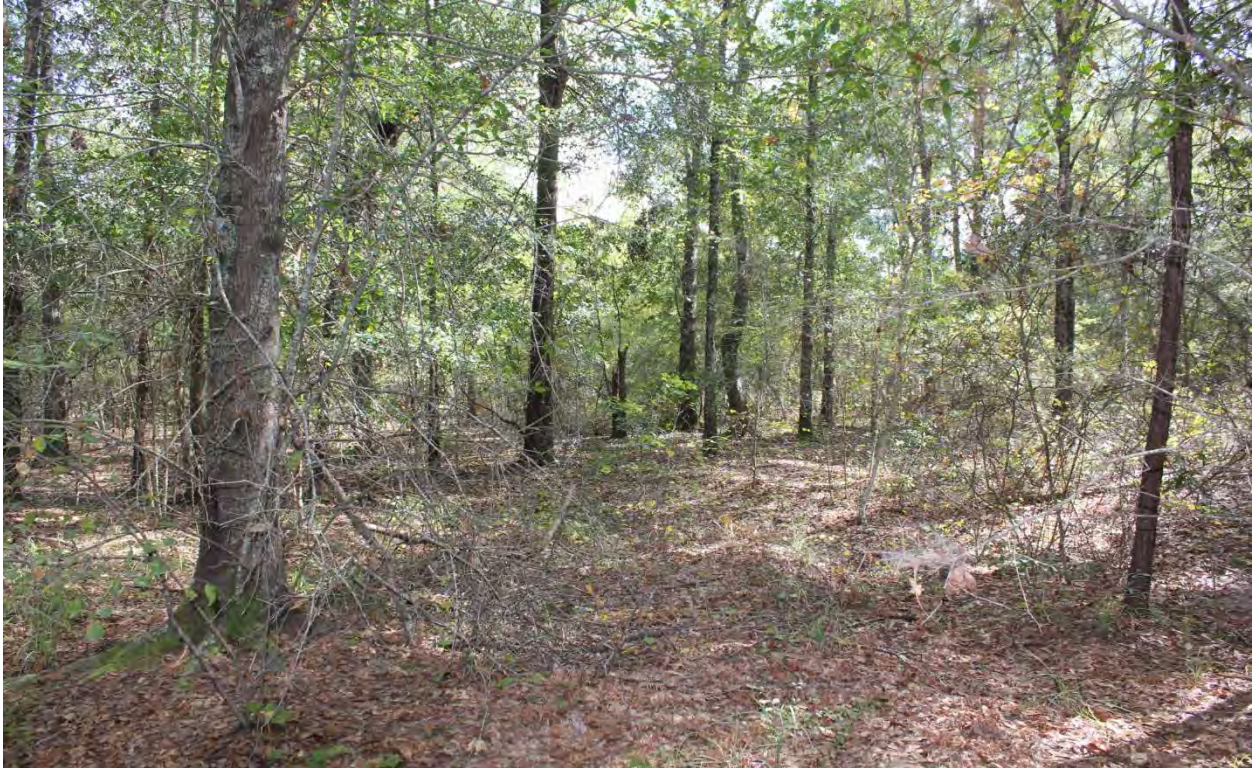
Photograph 13. Mixed hardwood/pine upland

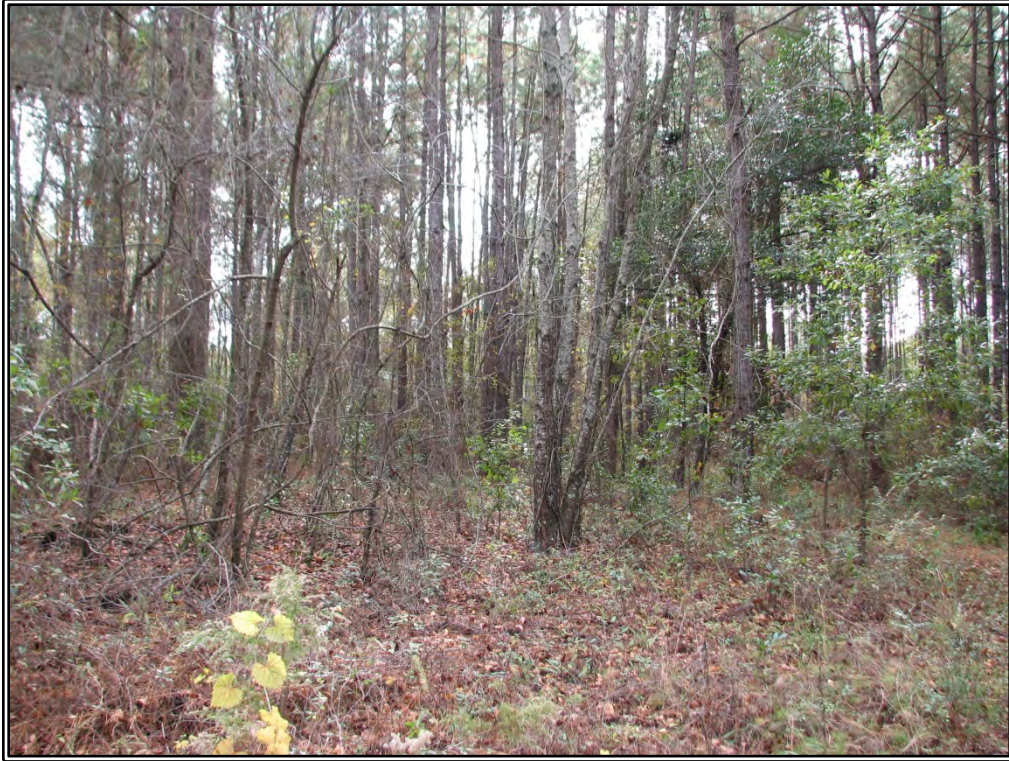
Photograph 1. View of Area 1, looking west.

Area 1 was located in the wooded southeast corner of the project tract (see Figure 1.3). Five transects were run and 28 shovel tests were excavated. Soils consisted of brown sandy loam 0-20 centimeters below surface (cmbs) overlying yellow sand 20 to 30 cmbs followed by orange sand subsoil containing concretions. Photographs 1 and 2 provide images of Area 1.

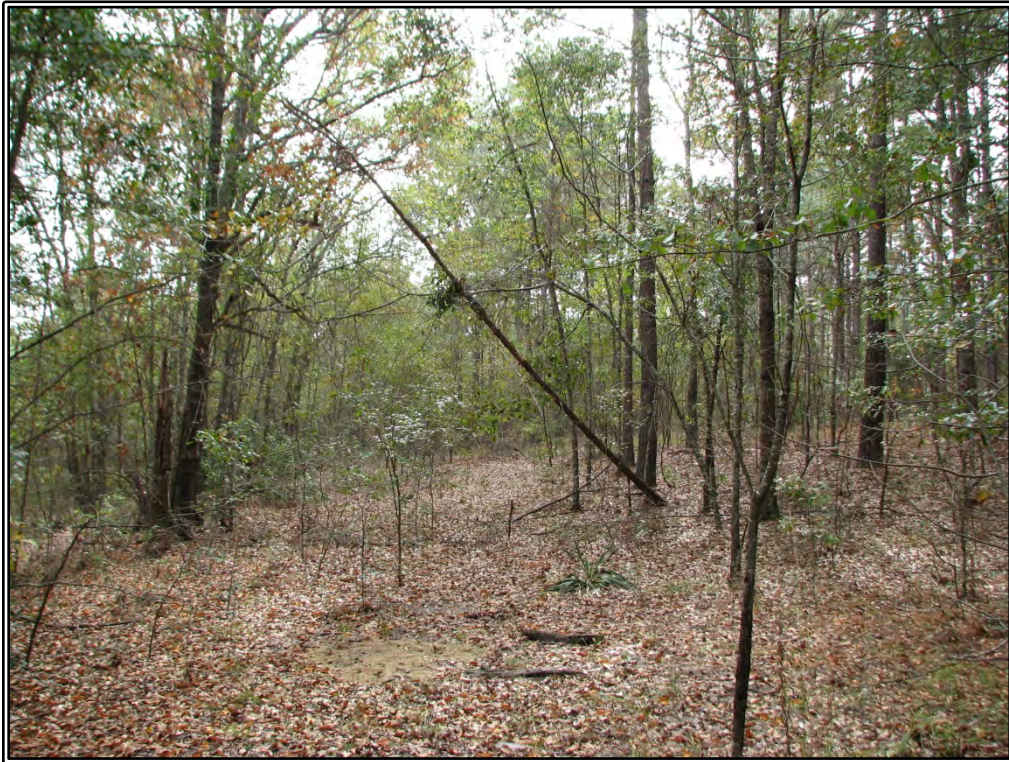
Photograph 2. View of Area 1, looking southwest.

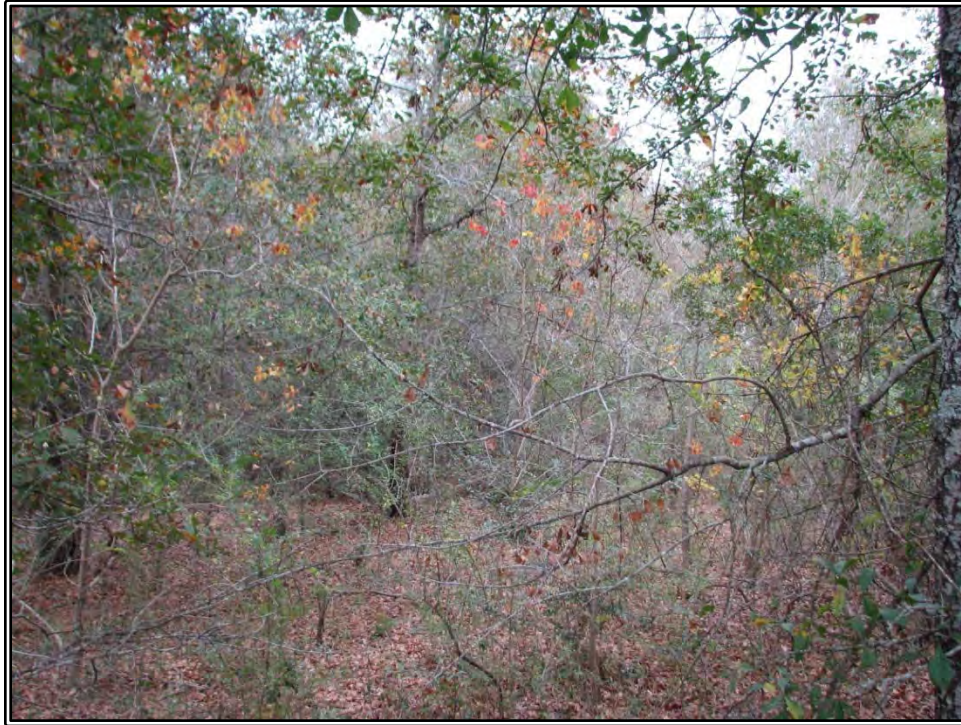
Photograph 3. View of Area 2, looking southeast.

Area 2 was located in the wooded west central area of the tract near Warrior Creek (see Figure 1.3). Five transects were run and 25 shovel tests were excavated. Soil in this area varied and consisted of gray sandy loam 0 to 25 cmbs overlying orange sand subsoil containing concretions 25 to 35 cmbs. In some areas soils consisted of gray loam 0 to 10 cmbs

overlying brown sandy loam 10 to 45 cmbs, followed by orange sand subsoil containing concretions. Photographs 3 and 4 provide images of Area 2.

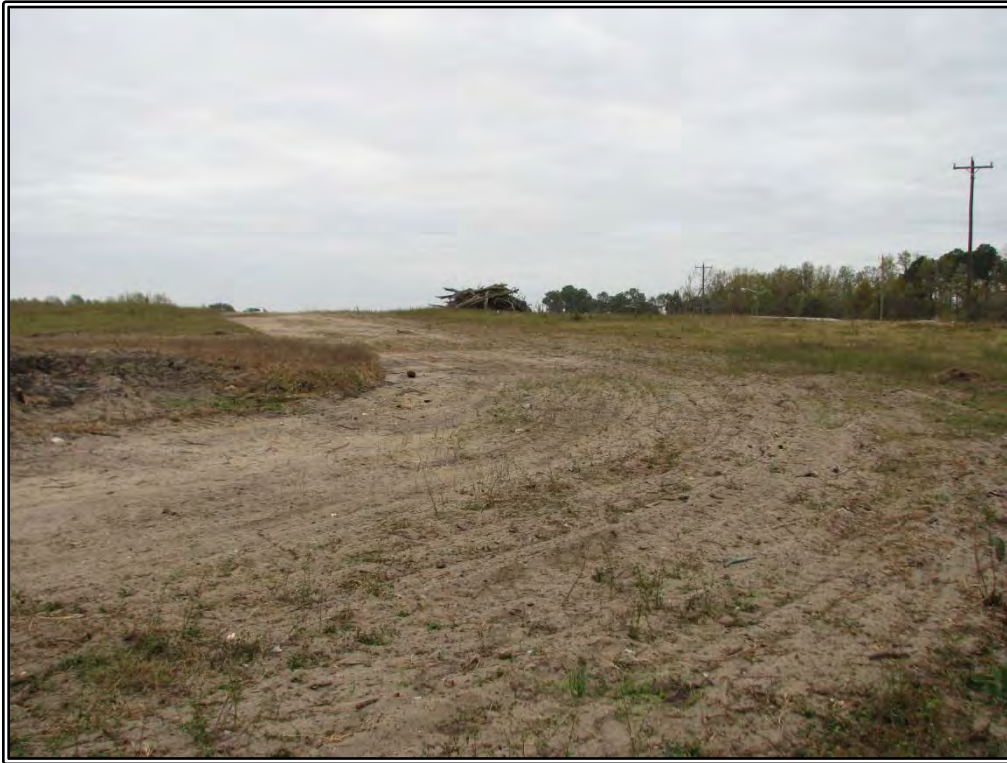
Photograph 5. View of Area 3, looking northeast.

Area 3 was located in the former pecan orchard in the northwestern corner of the tract (Figure 1.3). Four transects were run. Due to excellent surface visibility, only five shovel tests were excavated. Soils in this area consisted of brown sand 0 to 30 cmbs, overlying yellow sand 30 to 60 cmbs, followed by orange sand subsoil containing concretions 60 to 70 cmbs. Photograph 5 provides a view of Area 3.

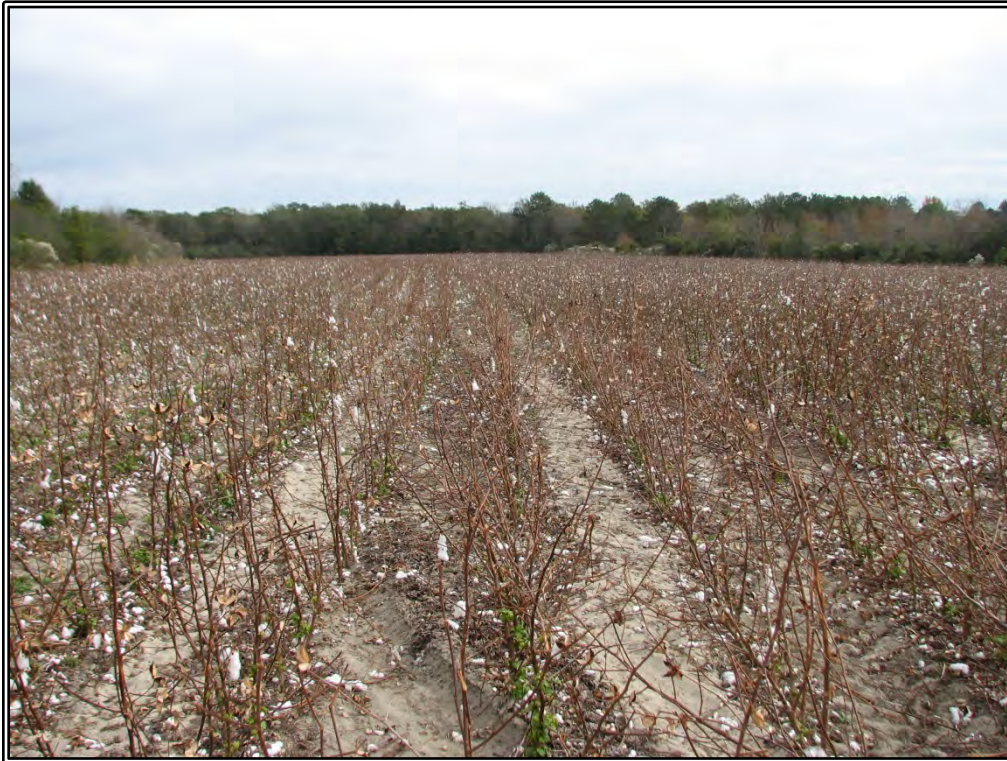
Photograph 6. View of Area 4, looking southeast.

Area 4 was located in the central area of the tract and consisted of cotton fields (see Figure 1.3). Five transects were run and due to excellent surface visibility, only nine shovel tests were excavated. Soils in this area consisted of brown sandy loam 0-20 cmbs overlying orange sand subsoil containing concretions 20-45 cmbs. However, in some areas subsoil was encountered at 10 cmbs. Photograph 6 provides a view of Area 4.

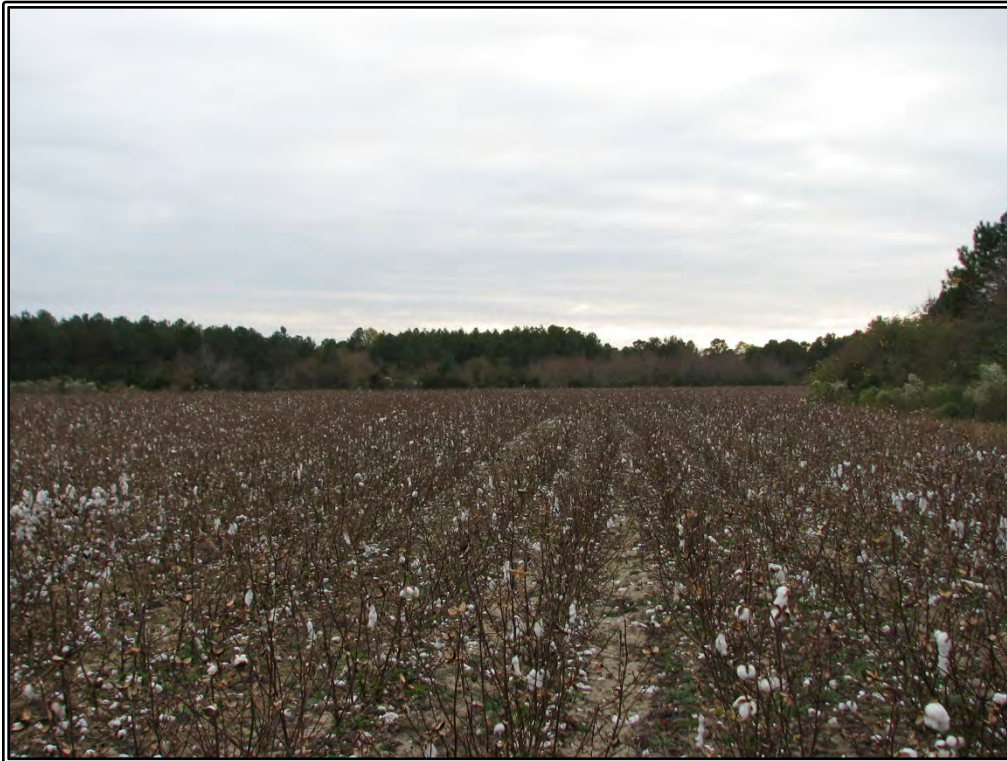
Photograph 7. View of Area 5, looking east.

Area 5 was located in the east central area of the tract and consisted of a cotton field and wooded landform west of Warrior Creek (see Figure 1.3). Five transects were run and due to excellent surface visibility, only five shovel tests were excavated. Soils in this area consisted of brown sandy loam 0-20 cmbs overlying orange sand subsoil containing concretions 20-45 cmbs. However, in some areas subsoil was encountered at 10 cmbs. On the wooded landform soils consisted of gray loam 0 to 10 cmbs overlying brown sandy loam 10-45 cmbs, followed by orange sand subsoil containing concretions 45 to 55 cmbs. Photograph 7 provides a view of Area 5.

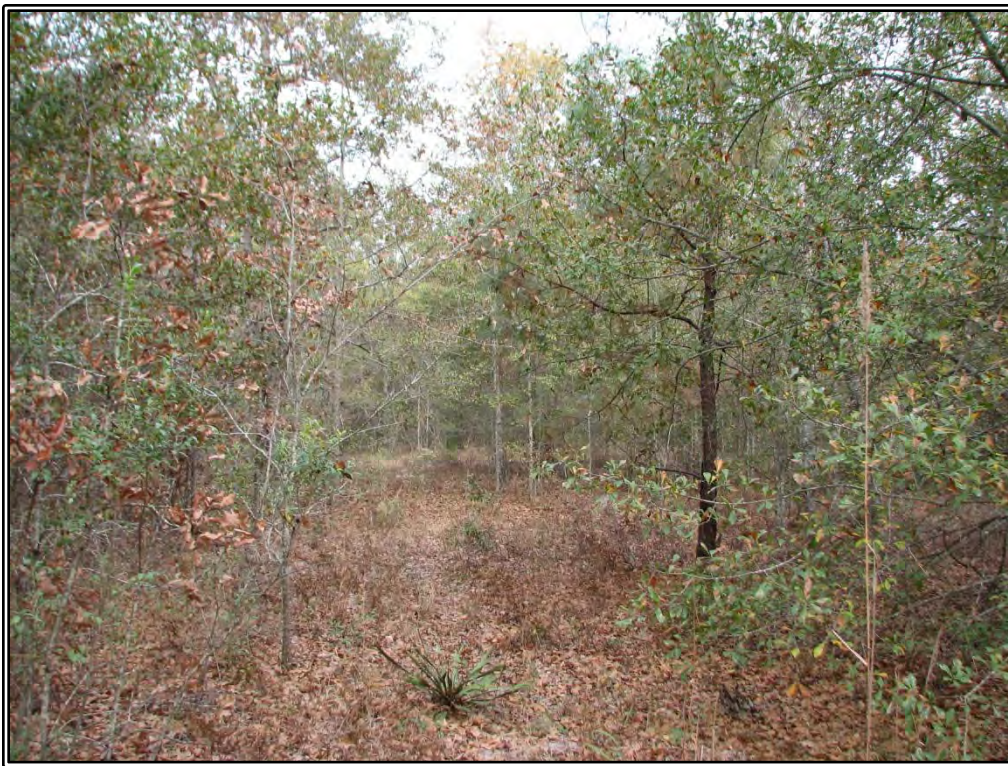
Photograph 8. View of 9WO54, looking northeast.

Site 9WO54 is a small prehistoric lithic scatter located in Area 1 (see Figures 1.2 and 1.3). Four positive and nine negative shovel tests were excavated at the site. Photograph 8 provides an image of 9WO54. Soils at the site consisted of brown sandy loam 0 to 10 cmbs, overlying yellowish brown sand 10-40 cmbs, followed by yellowish orange sand subsoil containing concretions 40 to 50 cmbs. Artifacts recovered consisted of Coastal Plain Chert flakes. These flakes were recovered from 10 to 40 cmbs. Soils at the site appeared to be relatively intact. As a result, additional testing could reveal intact cultural features or diagnostic artifacts. Therefore, 9WO54 is recommended potentially eligible for the NRHP. Photograph 8 provides a view of 9WO54.

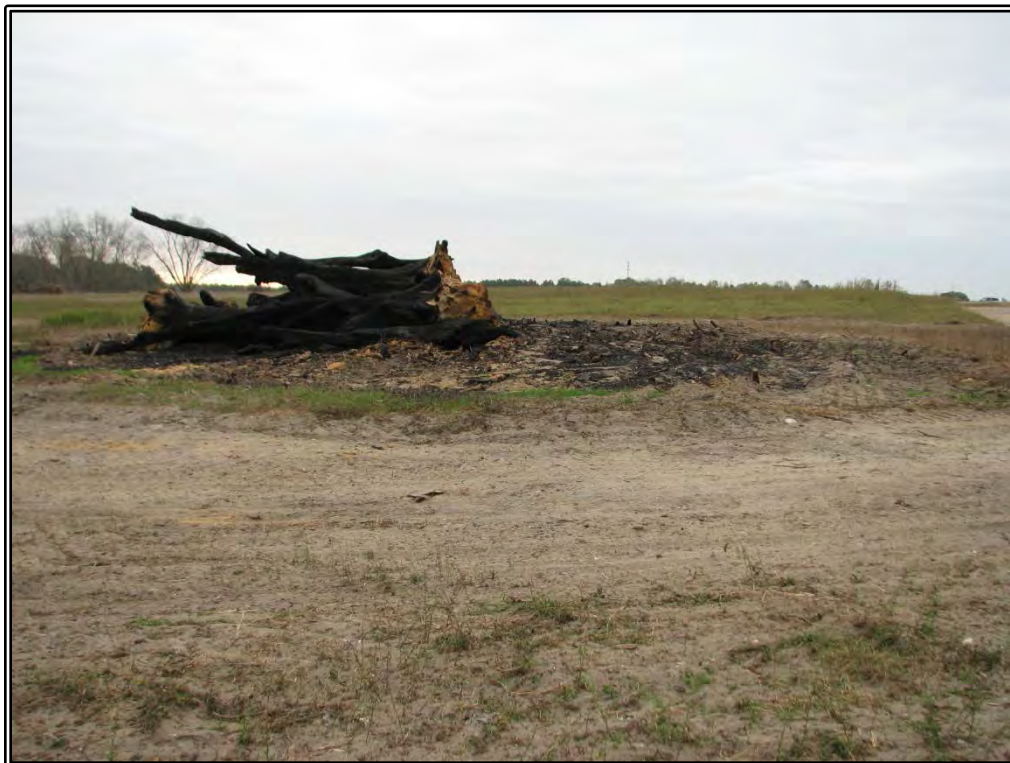
Photograph 9. View of 9WO55, looking southeast.

Site 9WO55 is an early to mid-twentieth-century artifact scatter located in Area 3. The current USGS topographic quadrangle does indicate a building was located in this area (see Figures 1.2 and 1.3). Until recently, much of Area 3 consisted of a pecan orchard and at present the area has been clear cut and partially bulldozed. Photograph 9 provides an image of 9WO55. Site 9WO55 also appears to have been bulldozed and graded. Surface visibility at the site was 90 percent and most of the artifacts collected were from the ground surface. Surface artifacts included two brick fragments, one clear glass bottle neck fragment, one green container glass

While historic artifacts were recovered from the ground surface and below ground surface, the majority of the site appears to be heavily disturbed from clear cutting and grading. Soils at the site were shallow and disturbed and it is unlikely that subsurface features are present. As a result, Site 9WO55 has low research potential and, therefore, appears to be ineligible for listing on the NRHP.

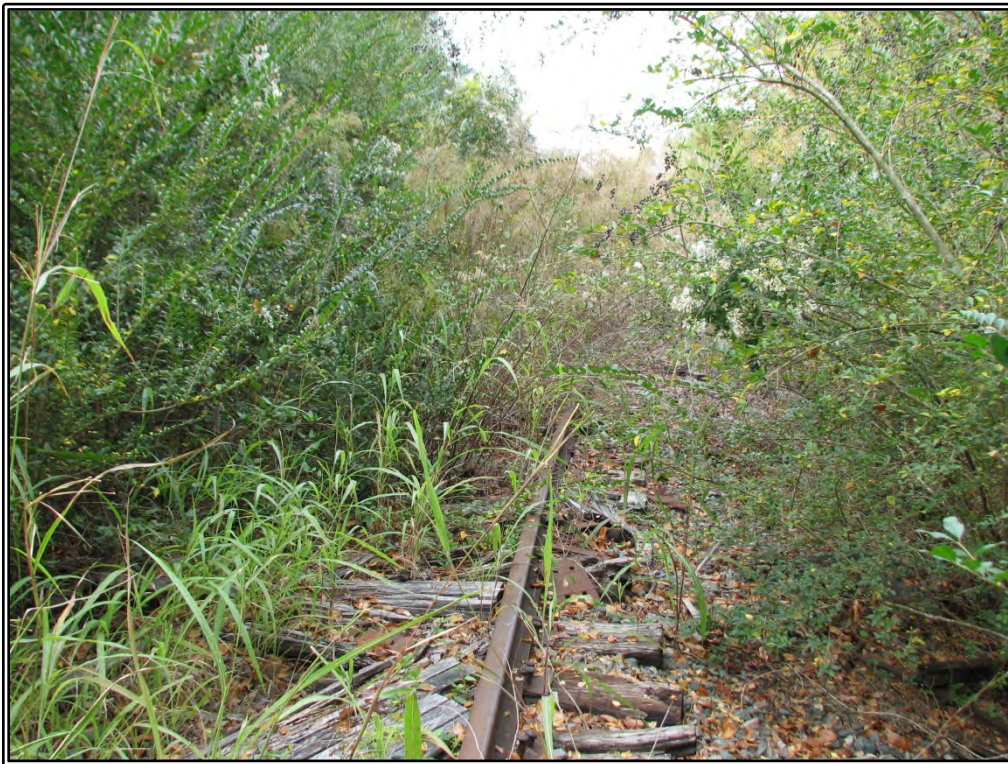
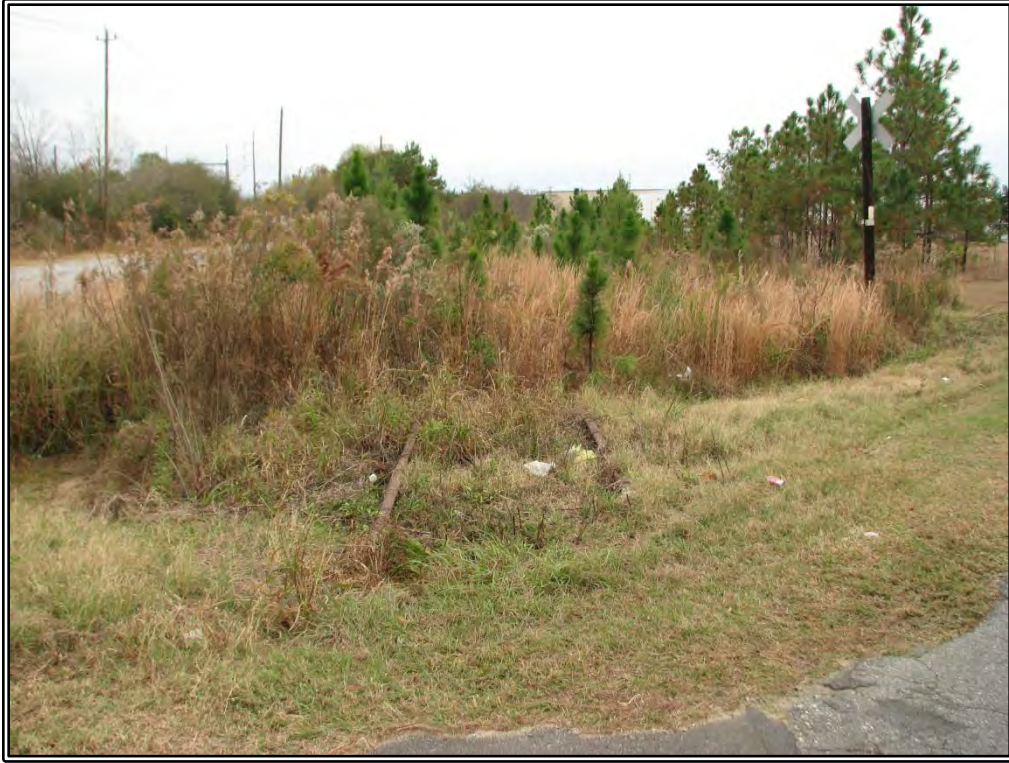
Photograph 10. View of Resource 1, looking northwest along the southwest project tract boundary.

Photograph 11. View of Resource 1, looking southeast from Seabrook Road.

Resource 1, the Brunswick and Western Railroad Corridor, was constructed in the late nineteenth century (see Figure 1.4). It was originally known as the Brunswick and Albany Railroad. However, this railroad company went bankrupt before the line was completed. The Brunswick and Western Railroad Corridor was organized in 1882 and extended from Albany, Georgia to Brunswick, Georgia.

Currently, the section of the railroad corridor within the project APE is abandoned. Although some sections of track have been removed the rail bed is still present and in many areas the track and railroad ties are still present. Resource 1, the Brunswick and Western Railroad Corridor, appears to retain sufficient integrity to be eligible for the NRHP under Criterion A, *event* and Criterion C *design/construction*. Photographs 10 and 11 provide images of the railroad corridor.

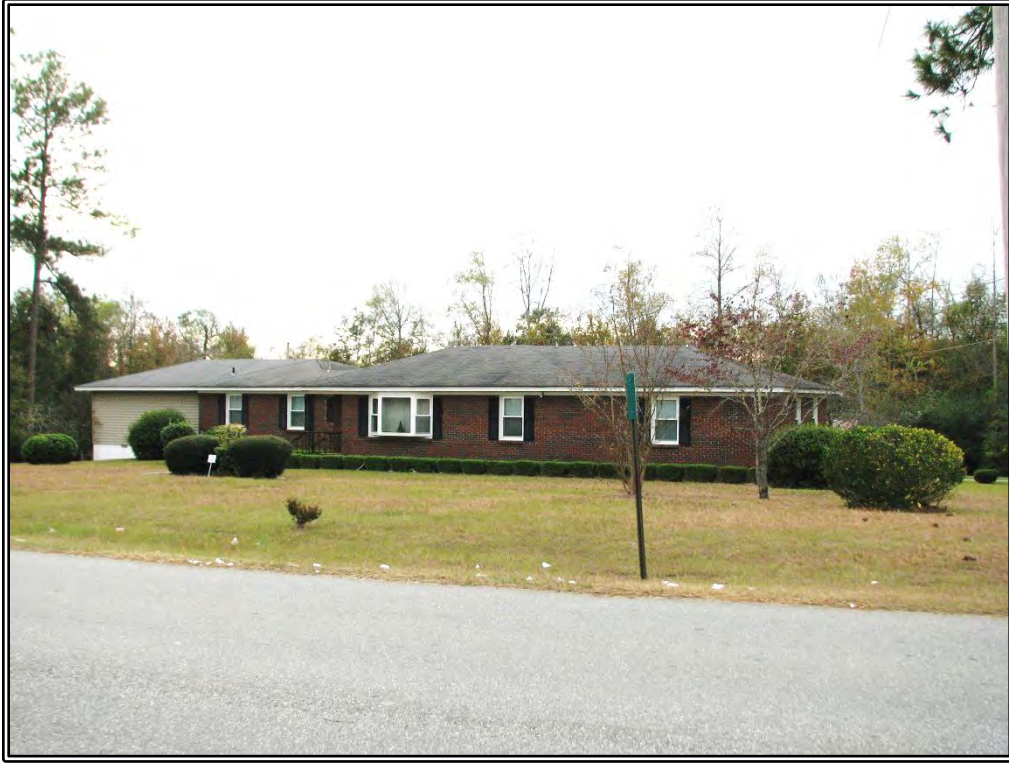
Photograph 12. View of Resource 2, east front elevation.

Resource 2 is a circa 1960 ranch house (see Figure 1.4). It has a concrete block foundation, a wood frame, a hip asphalt shingle roof, and brick veneer siding. The house also has an integral concrete portico with decorative cast iron supports. The front entry is accessed through this portico. Non-historic alterations include metal frame, vinyl coated replacement windows, including the front bay window. Non-historic additions include a large circa 1980 side addition with a combination of brick and vinyl exterior cladding. Due to non-historic alterations and additions, Resource 2 appears to be ineligible for the NRHP. Photograph 12 provides an image of the resource.

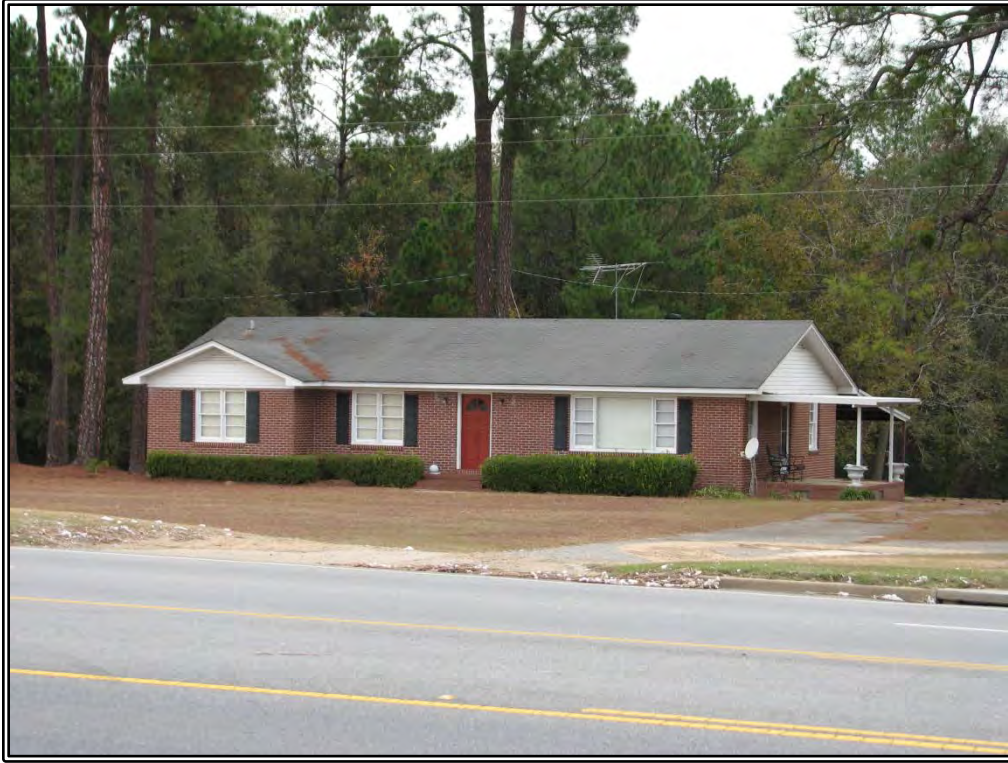
Photograph 13. View of Resource 3, south front elevation.

Resource 3 is a circa 1958 Ranch House (see Figure 1.4). It has a wood frame, a side gable asphalt shingle roof, a small projecting gable roof room on the front elevation, and a brick veneer exterior. The windows were wood frame, double hung, with 2/2 horizontal pane configurations. The house also has a large bay window on the front elevation with double hung side windows. On the east side elevation is a small shed roof porch with a concrete slab floor. The only alterations to the house are a non-historic door, with raised panels and a fan light, and vinyl siding in the roof gables. Resource 3 appears to retain sufficient integrity to be eligible for the NRHP under Criterion C *design/construction*. Photograph 13 provided an image of Resource 3.

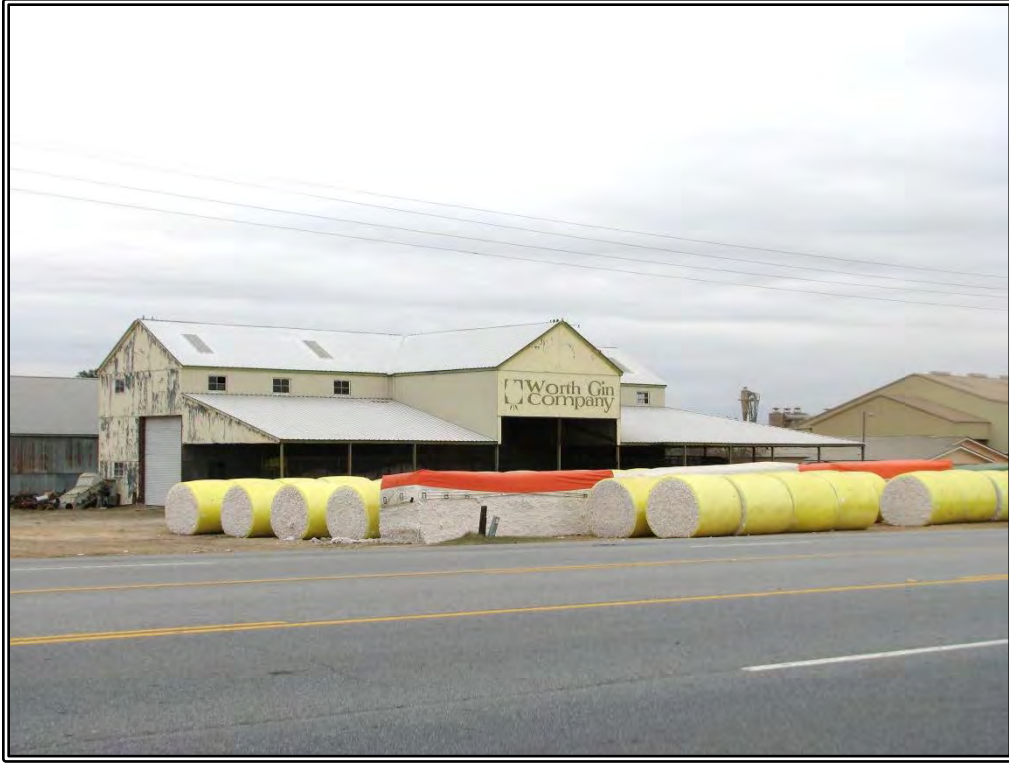
Photograph 14. View of Resource 4, circa 1960 main building, southwest oblique.

Resource 4 is a mid-twentieth-century cotton gin (Worth Gin Company). The main building appears to date to circa 1960 (see Figure 1.4). It has a metal frame and a side gable V-crimp metal roof. There is also a projecting gable roof on the front elevation. The exterior is clad in a combination of vertical wood planking and V-crimp metal. The windows appear to be metal frame awning windows. The metal cargo doors as well as most of the exterior cladding appear to be non-historic replacements. There are approximately six other buildings in the complex that appear to date from the late 1960s to the 1990s. Due to non-historic alterations to the circa 1960 building and the addition of many non-historic buildings to the property, Resource 4 appears to be ineligible for the NRHP under Criterion C *design/construction*. In addition, due the late construction date of the resource, it does not appear to be eligible for the NRHP under Criterion A *event*. Photographs 14 through 16 provide images of Resource 4.

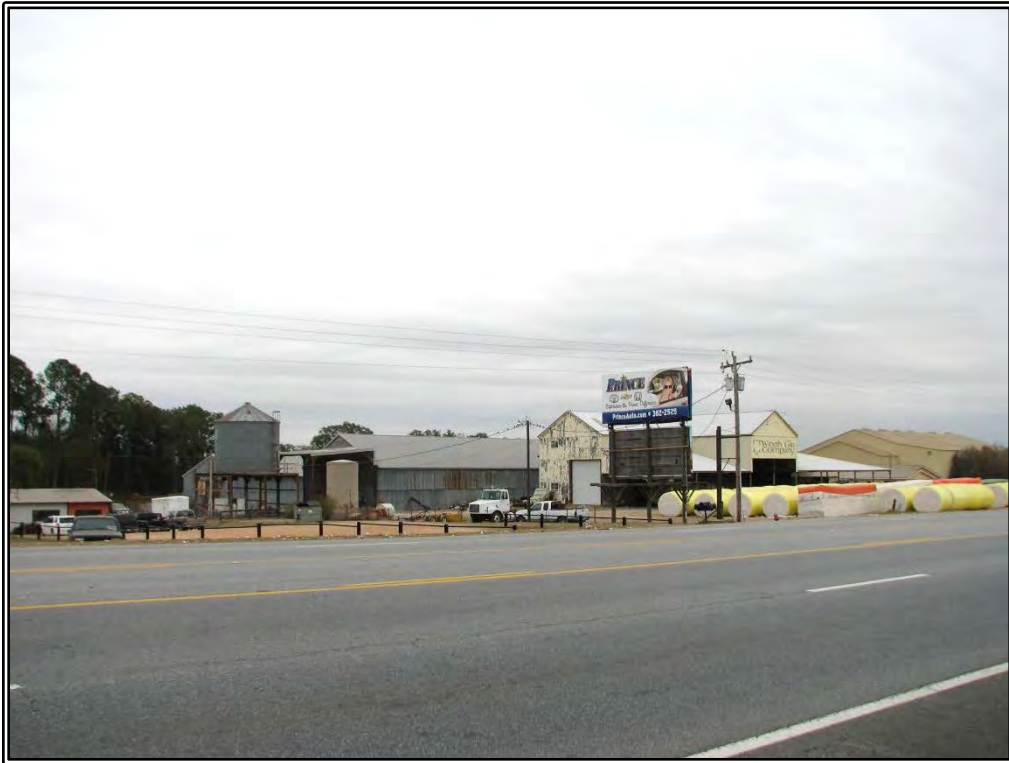
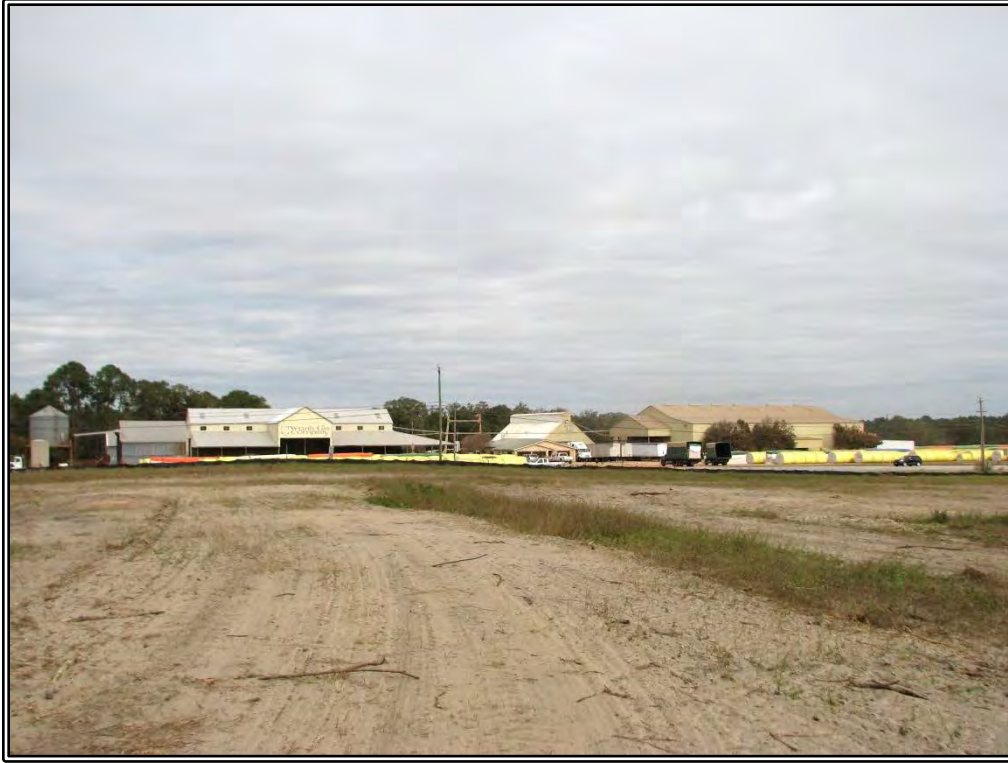
Photograph 15. View of the Resource 4 complex, looking northeast from US 82.

Photograph 16. View of the Resource 4 complex, looking north from the project tract.

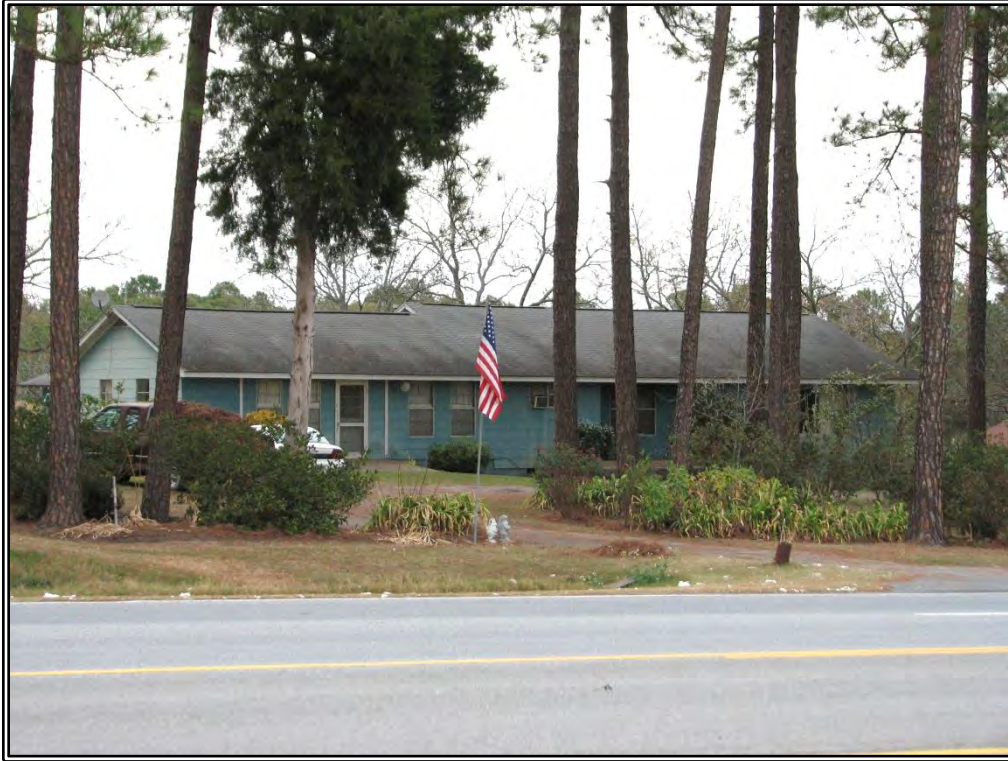
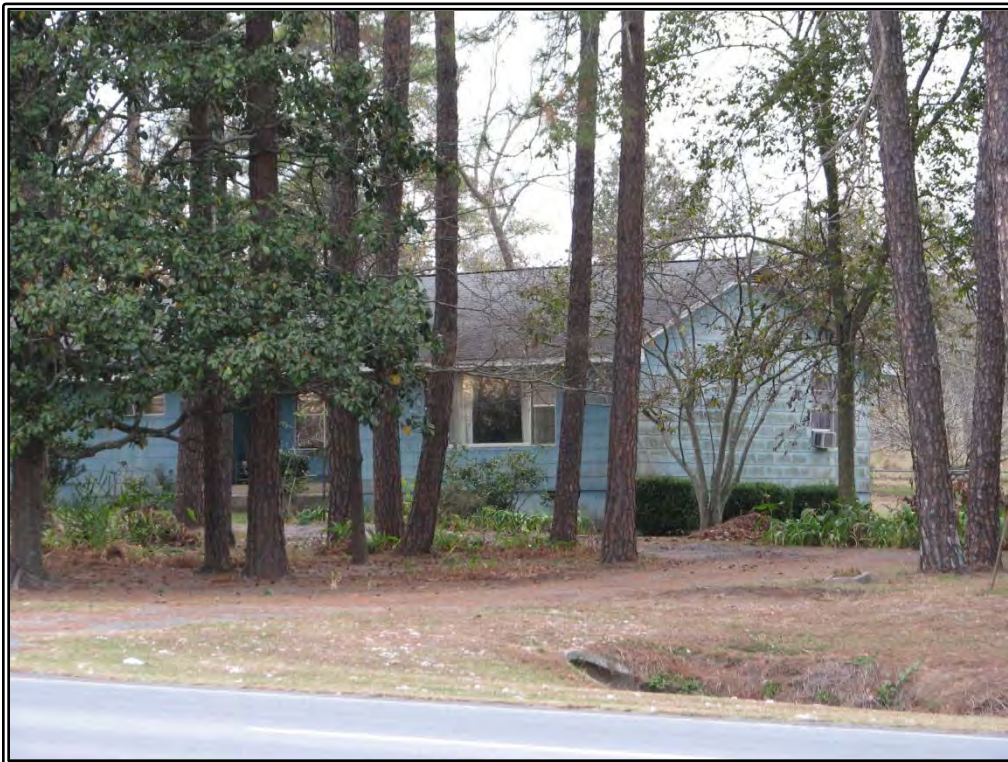
Photograph 17. View of Resource 5, south front elevation.

Photograph 18. View of Resource 5, southeast oblique.

Resource 5 is a circa 1955 Ranch house with outbuildings (see Figure 1.4). It has a continuous concrete block foundation, a wood frame and a side gable asphalt shingle roof. The house has wood frame, double hung, windows with 2/2 horizontal pane configurations, a large bay window on the front elevation, and a recessed front portico. The exterior is clad in composition or asbestos shingles. On the west side elevation is a large circa 1960 addition with similar windows and exterior siding to the original portion of the house. North of the house, on the same property is a pasture. Within the pasture are what appear to be three agricultural outbuildings with V-crimp metal roofs. However, due to access problems to the property detailed observation and photographs could not be made. Resource 5 appears to have been a compact ranch house. The side addition has significantly changed the footprint and compact appearance of the house. Therefore, Resource 5 appears to be ineligible for the NRHP as an individual resource. However, the Resource 5 property is potentially eligible for the NRHP as an agricultural property. Additional information will need to be gathered in order to fully evaluate the Resource 5 property as an agricultural resource. Photographs 17 and 18 provide photographs of Resource 5.
