**APPLICATION FOR SITE CERTIFICATION TO THE
GEORGIA ALLIES GRAD INDUSTRIAL SITE PROGRAM**

Worth County Economic Development Authority
122 North Main Street
Sylvester, Georgia 31791
P: 229-776-7599
F: 229-776-0233

EMC Engineering Services, Inc.
1344 US Hwy 19 S Suite A
Leesburg, Georgia

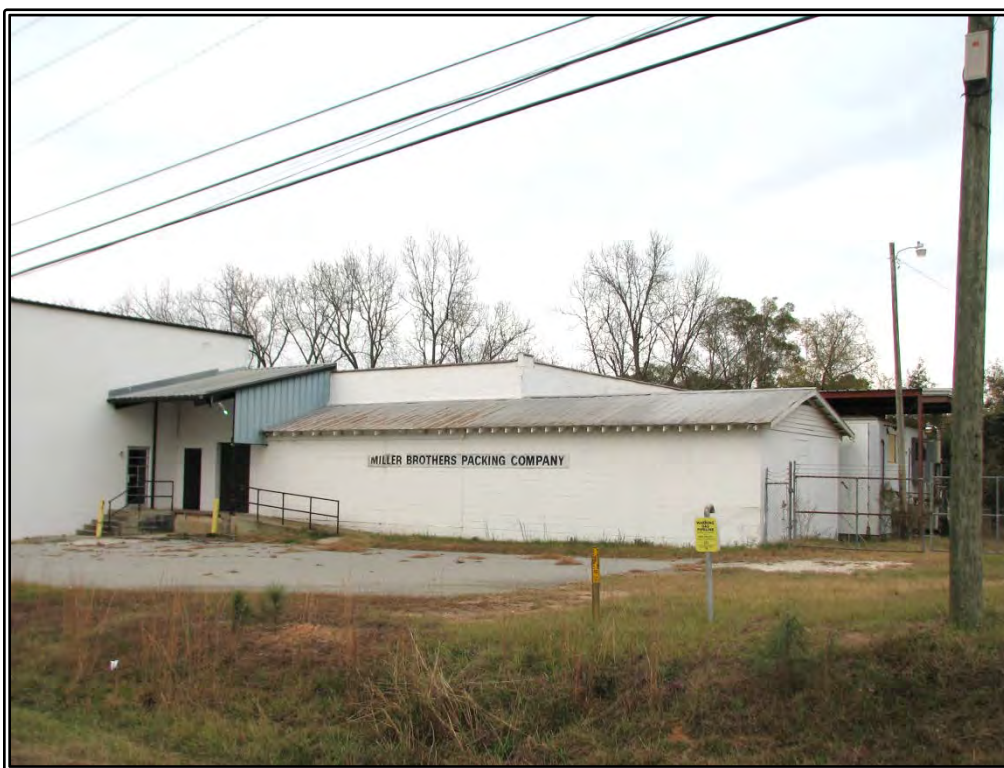
Photograph 19. View of Resource 6, northwest oblique, circa 1970 addition at left.

Resource 6 is a circa 1940 commercial building which most recently housed a packing company (see Figure 1.4). It has concrete block walls, a side gable V-crimp metal roof with exposed rafter tails, and weatherboard in the west gable. Alterations include windows that have been sealed with concrete blocks. On the rear of the building is a circa 1950 addition, it has concrete block walls and a flat roof with parapet walls that have terracotta tile caps. On the west side elevation is a large circa 1970 addition. It has concrete block walls, a flat V-crimp metal roof, and an aluminum frame glass entry door. Associated with the building is a circa 1955 workshop. It has a concrete block foundation, a wood frame, a front gable corrugated metal roof and corrugated metal siding. On the front elevation is a large wood frame corrugated metal sliding door. The windows on the side elevations are wood frame, double hung, with 6/6 pane configurations. However, due to non-historic alterations and additions, Resource 6 appears to be ineligible for the NRHP. Photographs 19 through 21 provide images of Resource 6.

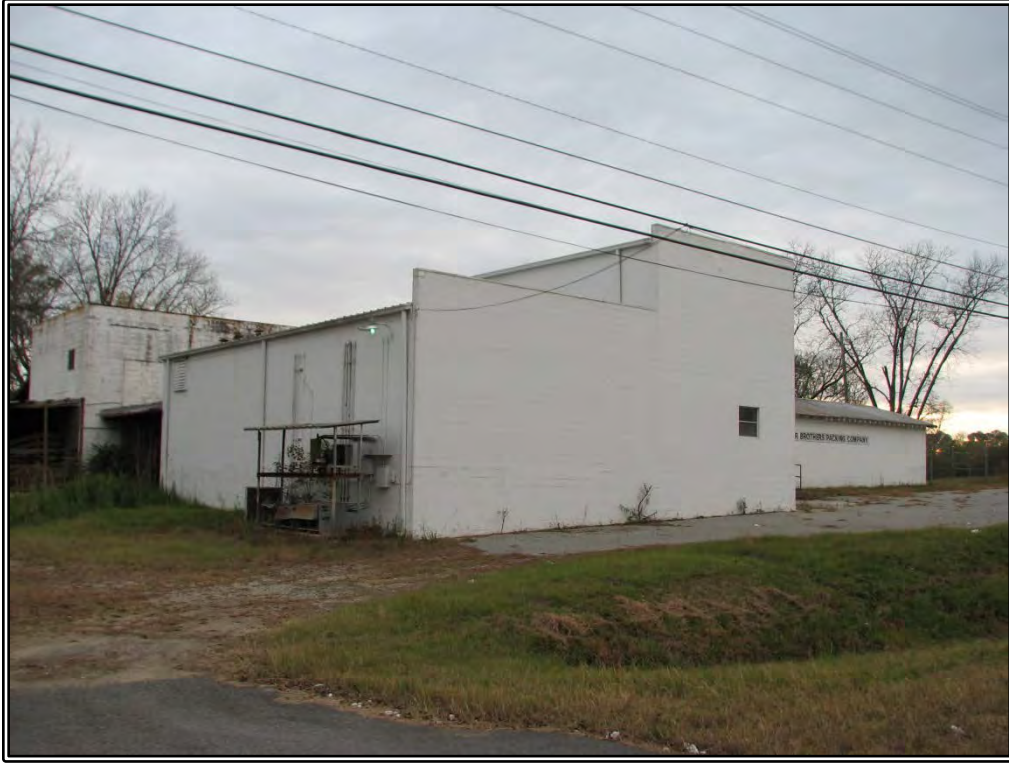
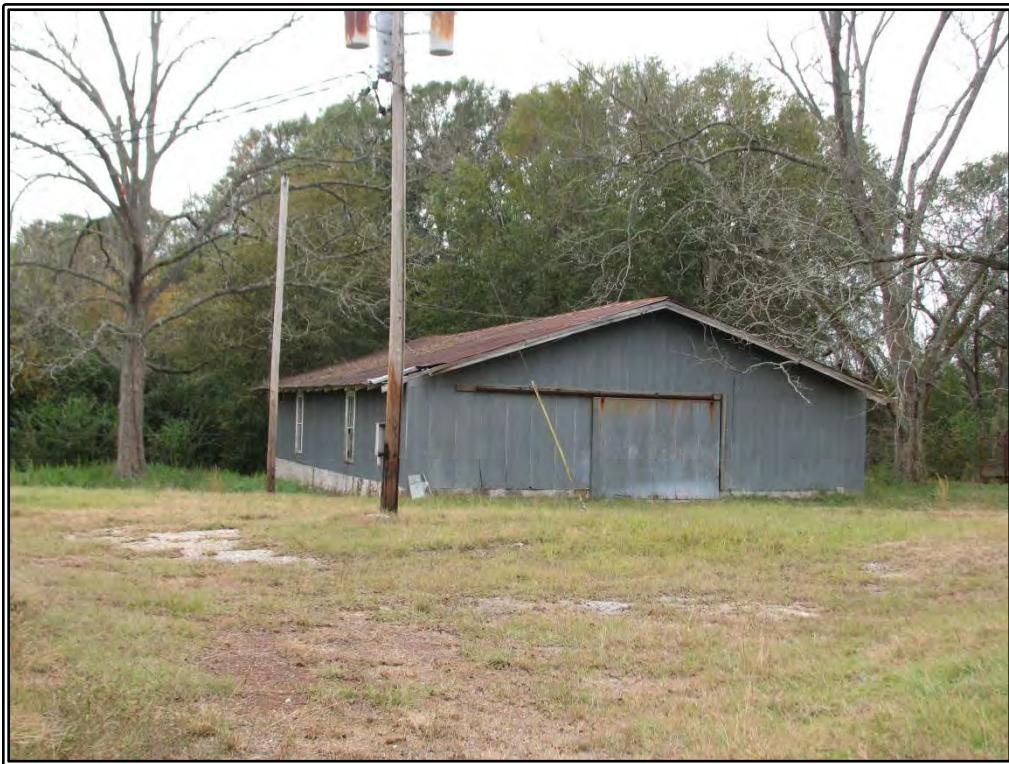
Photograph 20. View of Resource 6, circa 1970 addition, northeast oblique.

Photograph 21. View of Resource 6, associated workshop, northeast oblique.

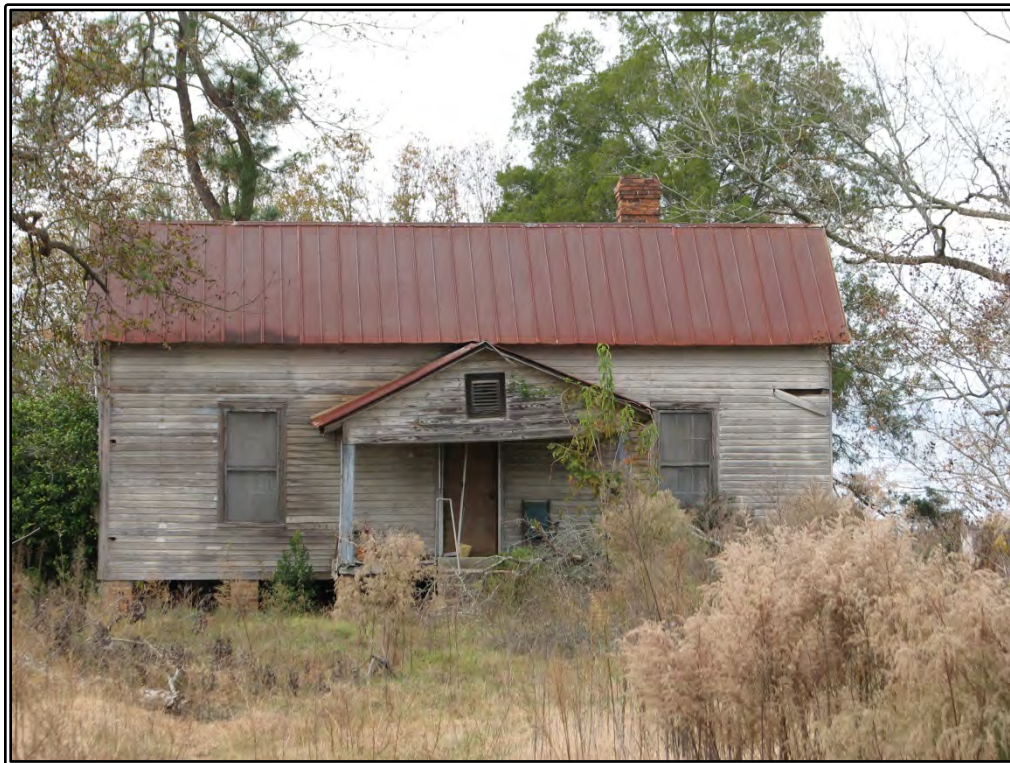
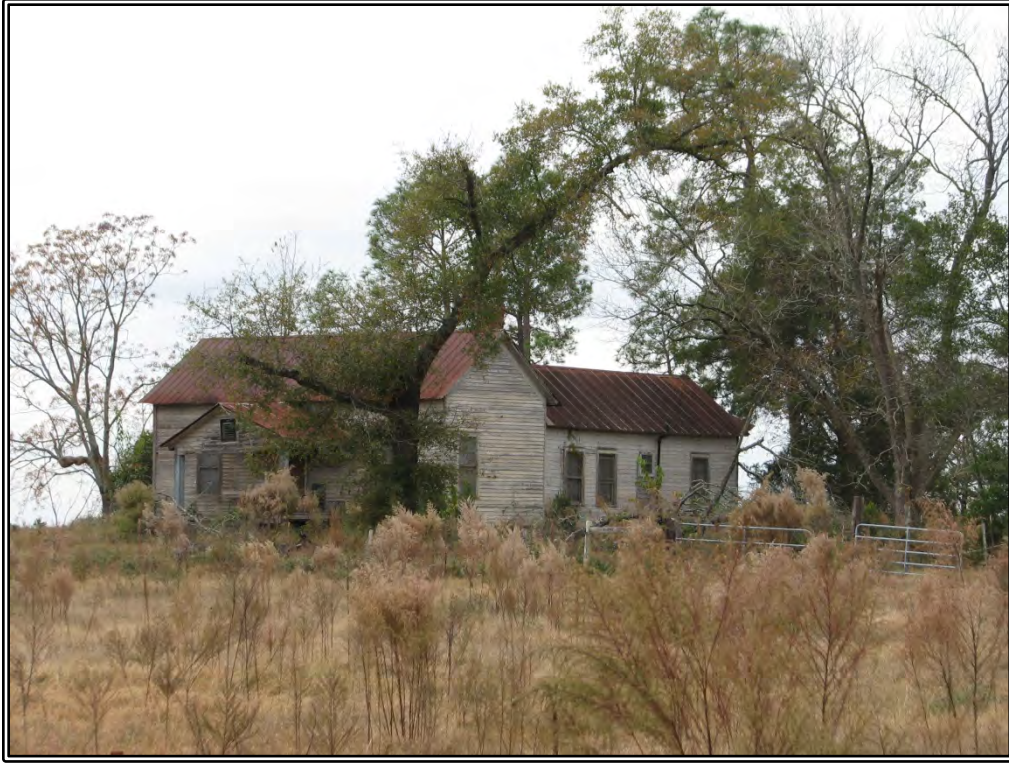
Photograph 22. View of Resource 7, east front elevation.

Photograph 23. View of Resource 7, northeast oblique.

Resource 7 is a circa 1900 central hall house (see Figure 1.4). It has a brick pier foundation, a wood frame, and a side gable V-crimp metal roof. The house has wood frame double hung windows with 6/6 pane configurations, a single front door, and weatherboard siding. On the front elevation is a partial gable roof porch with a brick pier foundation, a wood plank floor, and wood post supports. On the rear of the house is an ell extension with a gable roof and a single interior brick chimney. The only alteration to the house is a circa 1970 hollow wood front door. In addition, the house is situated in a pasture. Within the pasture is what appears to be a barn with a V-crimp metal roof. However, due to access problems to the property detailed observations and photographs could not be made. Photographs 22 and 23 provide views of Resource 7.

Resource 7 appears to be eligible for the NRHP under Criterion C *design/construction*. However, the Resource 7 property is potentially eligible for the NRHP as an agricultural property. Additional information will need to be gathered in order to fully evaluate the Resource 7 property as an agricultural resource.
